# Digital Mandibular Arch Restoration at an Increased Occlusal Vertical Dimension in One Visit

**Abstract:** This case demonstrates how a fully digital technique was used to restore the mandibular arch to proper function and esthetics. The initial treatment plan of implants replacing the lower right molars had to be altered due to space limitations. A direct deprogrammer was utilized to determine the proper jaw relationship at an acceptable occlusal vertical dimension. A computer-aided design system was employed to digitally create and fabricate implant/abutment-supported cement-retained lithium-disilicate crowns, tooth-supported lithium-disilicate crowns, and screw-retained abutment lithium-disilicate crowns in one visit.

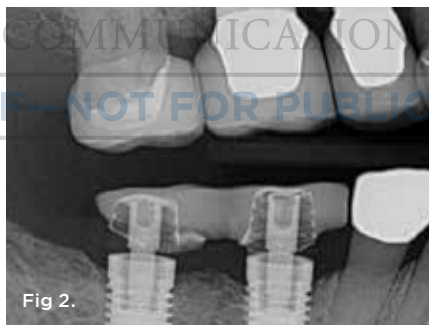
Records from her local surgeon and dentist were requested. Radiographic review (Figure 2) and emails from her regular dentist prompted concern about a lack of adequate interocclusal space for final restorations. Due to limited space, screw-retained abutment/crowns were planned.

**Fig 1.** The patient as she presented at the initial examination. **Fig 2.** Radiograph of the provisional on implant Nos. 30 and 31. **Fig 3.** A preoperative panorex scan taken with the maxillary provisionals in place. Note the heavily restored dentition. **Fig 4.** A preoperative occlusal view of the mandibular arch, revealing broken porcelain and thin acrylic on the lower right. **Fig 5.** The mandibular incisors from 2008 showed minimal change in attrition. **Fig 6.** A preoperative view revealed the low mandibular posterior occlusal plane.

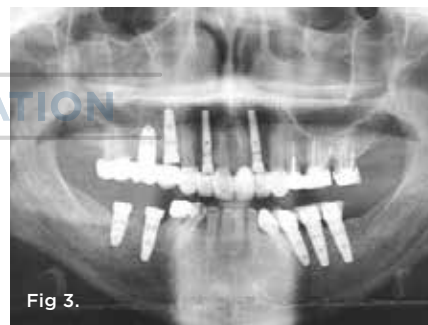
**Biomechanical:** The patient had an extensive history of restorative dentistry and a period of high caries susceptibility as a young adult (Figure 3). Except for teeth Nos. 23 to 26, all remaining teeth were structurally compromised. Tooth loss, except for the third molars and first bicuspid, was for biomechanical reasons. The maxillary arch had been restored in 2012, and a healing cap was in place on the implant replacing tooth No. 13. On the mandibular arch, a screw-retained acrylic provisional on implant Nos. 30 and 31 (Figure 4), cemented crowns on implant abutments for teeth Nos. 18, 19, and 20, and porcelain-fused-to-metal crowns on teeth Nos. 22 and 29 were present. The restorations on teeth Nos. 18, 22, and 29 were defective, and those on teeth Nos. 25 and 27 were questionable. Erosion was noted on tooth No. 24.

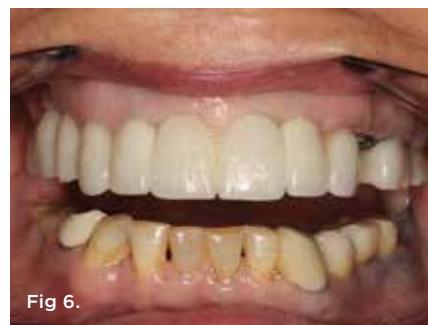
**Dentofacial:** The patient exhibited high maxillary lip dynamics. The mandibular lip dynamics were medium, and dark lower teeth and restorations were present. The vertical height of the posterior mandibular occlusal plane was lower than that of the mandibular anterior teeth (Figure 6). If additional interocclusal space was needed to restore the lower right implants, increasing the OVD by expanding the height of the mandibular posterior teeth would be acceptable esthetically.

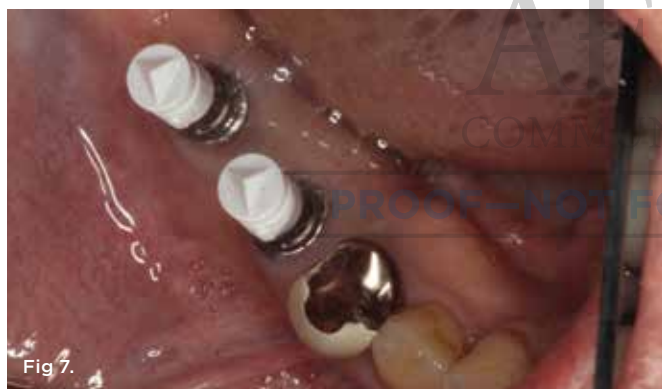
Fig 7.

The treatment began with taking preoperative photographs and performing a clinical examination. Following removal of the lower right provisional and placement of the scan posts (Dentsply Sirona, sironausa.com) and scan bodies (Dentsply Sirona) (Figure 7), a digital impression was taken of each arch and a buccal bite registration. During the CEREC™ (Dentsply Sirona) computer-aided design process, the team realized insufficient interocclusal space existed to create hybrid abutment crowns (Figure 8). Removal of porcelain from the opposing arch was not an option. The decision

**Fig 7.** The scan posts and scan bodies in place on the abutments for implant Nos. 30 and 31. **Fig 8.** The area in red revealed the amount of space that was lacking for proper restorative contour. **Fig 9.** After the removal of the lower left crowns with the direct deprogrammer in place. **Fig 10.** The milled crowns for the lower left.

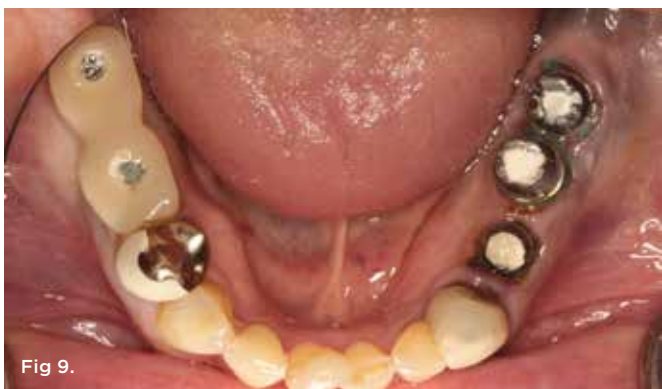
Fig 9.

Stage 2 was creation of the implant abutment-supported cemented crowns for teeth Nos. 18 to 20.<sup>4</sup> The existing crowns were removed, using an electric handpiece, and the tissue was retracted with No. 00 and No. 2 retraction cords to access and take images of the existing abutment margins (Figure 9). The CEREC Omnicam (Dentsply Sirona) camera was used for digital impressions of the upper and lower left quadrants and a buccal bite registration while the jig provided a stable stop at the desired OVD.

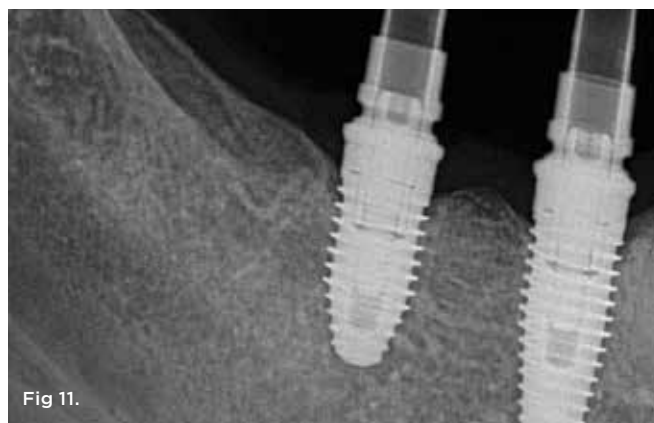
Fig 11. The scan posts in place on the lower right. Fig 12. A radiograph confirming proper fit and seating of the final restorations on the lower right.

Stage 3 involved screw-retained implant-supported abutment crowns on implant Nos. 30 and 31 with an e.max crown on tooth No. 29.<sup>7</sup> The provisional restoration on implant Nos. 30 and 31 was removed and images of the soft tissue coronal to the implants were taken to capture the contours for designing the proper emergence profile of the final restorations. Two scan posts were placed into the implants, and full seating was confirmed radiographically (Figure 11). An appropriate scan body was seated over the scan post specific to the implant system and diameter, to digitally transfer the exact position of the hex on the integrated implant. Tooth No. 29 was prepared according to biomechanical principles and tissue packed with No. 00 and No. 2 retraction cords.

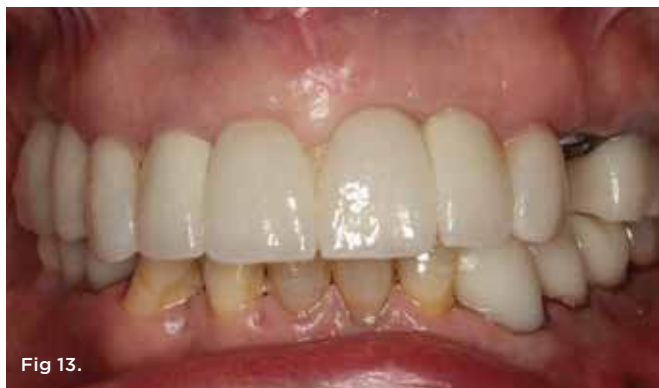
Fig 13.

**Fig 13.** After treatment completion, the dentition in maximal intercuspital position. **Fig 14.** The correction of the occlusal plane can be seen in this postoperative photograph. **Fig 15.** The mandibular arch after treatment completion.

the porcelain was polished. After the anesthetic had worn off, the patient was able to feel her bite and could chew comfortably. The patient said she was pleased with the results both functionally and esthetically (Figure 13 through Figure 15).
